SUBJECT: Re-issue of Asbestos Inspection Report
Liberty Fibers Corporation
Lowland, TN
Project Nos. 08-0515/08-0605

Asbestos Investigation Report
Liberty Fibers Corporation
Lowland, Tennessee

Dates of Study: May 28 and May 29, and July 2, 2008

Document Type: Investigation Final Report

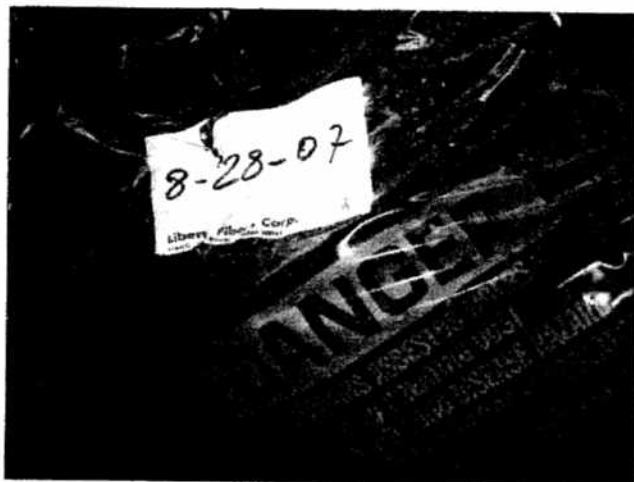
Figure 3, Asbestos Disposal Bags

The bags were in relatively good condition with few having rips or holes. The majority of the bags are labeled, but do not identify any of the removal or facility information (Figure 3). The earliest date seen on labels which were visible was February 2007, but since the vast majority of the labels could not be seen, there may have been some with dates earlier than February 2007. It cannot be determined how old the bags without labels might be. The bags themselves are of differing material. Some are bags made for asbestos removal that are 6 mil thickness with hazard labeling, but most bags were 3 mil general contractor bags or even thinner black yard trash bags. Also, an empty 3 mil contractor clean-up bag box was found in the asbestos storage building (Figure 5).

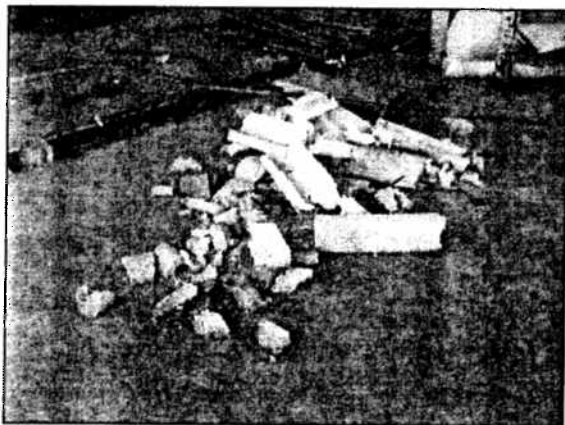
Figure 6, Detail of one pile of removed ACM

The last area that was investigated was in the southern area of the salt plant. This area was large with scattered piles of debris of various types. Reports indicated that ACM may be buried in this area, but the inspectors could not find a suspicious location due to the amount of debris. However, while searching the area, the inspectors found a couple of areas of interest. The first area contained two piles approximately 6' x 3' of what appeared to be removed TSI (Figures 6 & 7). The material was dry and underneath a tall roof that was still intact. Pipes with lagging and TSI were also found scattered throughout the salt plant debris pile. Bulk samples were collected from these materials and the details are listed in Table 1, Sample Identification and Description and Table 2, Polarized Light Microscopy Sample Analysis Summary.
